**Flood Control Project Maintenance
Levee Inspections**

Maintenance Issue Types Only, Levee Inspection Report By Mile - Spring 2017

Sacramento River West Side Levee District

Waterway	Bank	Unit Miles	Inspection Start/End	Inspector
Unit No. 01 Sacramento River	Right	49.64	03/21/2017 03/22/2017	Zach Jojola

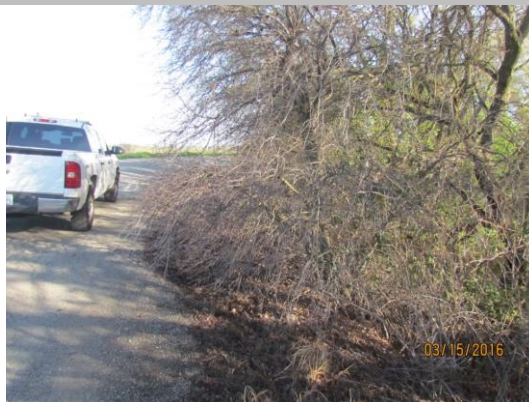
Photo 1 of 1 : SP_2017_NA0016_435_104_20170320_00052.jpg

LM Start	0.08	Rating **	M	Issue No.	104
LM End	0.25	Issue Type +	Ma	Location *	WS
Category	Earthen Levee			GPS Latitude/Longitude	
				Start	End
Item	Trim / Thin Trees			38.800642 °	38.802413 °
				-121.724723 °	-121.724317 °
DWR ID	DWR_NA0016_01_s_2016_104				
Comment Code					
T1 : Trim trees to at least five feet above ground level.					
Inspector Comment

View of the tree branches on the waterward side of the levee looking upstream. Spring 2016.

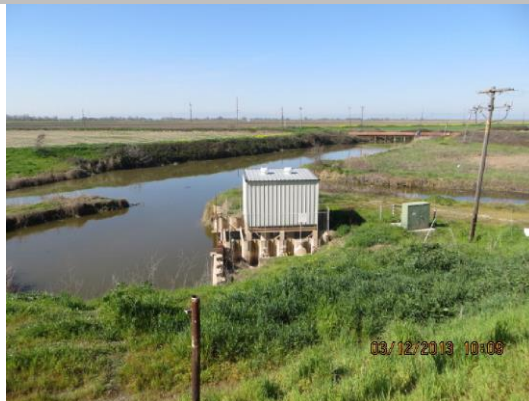
Photo 1 of 3 : UCIP_SP_2017_10087_17235.jpg

LM Start	0.14	Rating **	M	Issue No.	1551
LM End	0.14	Issue Type +	Ma	Location *	WS
Category	Supplemental			GPS Latitude/Longitude	
				Start	End
Item	DWR UCIP LMA Responsibility			38.801471 °	38.801471 °
				-121.725171 °	-121.725171 °
DWR ID					
Comment Code					
Inspector Comment					
FS_ID:10087					
DS_ID:20224					
EP_NO: N/A					
Repair Type: Non-Urgent					
Crossing Status: Found					
UCIP Comments: Headwall on WS undermined about 3-4-feet.					
FIELD_STRUCT_DESC: 1 of 3: 36-inch steel drainage pipe through					
levee 30.0 feet below crown. Flap gate on the waterward end. 24-inch					
pipe sleeved through the 36-inch pipe. Annular space between pipes					
grouted. Pumps in pumphouse with walkway on LS toe. Originally					
included in the 1960 O&M manual.					
FS Date: 3/12/2013

Pumphouse at LS toe.

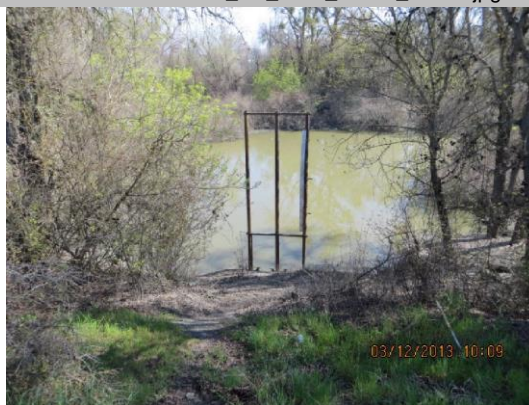
Photo 2 of 3 : UCIP_SP_2017_10087_17234.jpg

Air vents at outlet on WS toe.

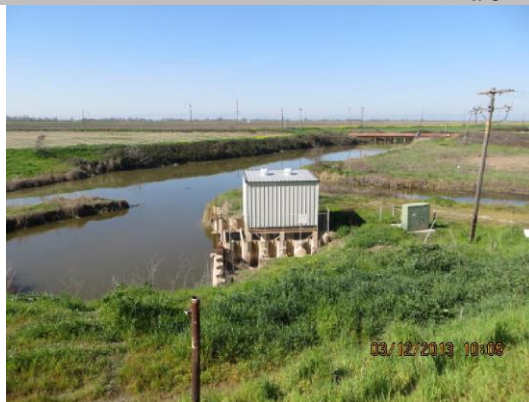
Photo 1 of 3 : UCIP_SP_2017_10085_17227.jpg

LM Start	0.14	Rating **	M	Issue No.	1552
LM End	0.14	Issue Type +	Ma	Location *	WS
Category	Supplemental			GPS Latitude/Longitude	
				Start	End
Item	DWR UCIP LMA Responsibility			38.801479 °	38.801479 °
				-121.725176 °	-121.725176 °
DWR ID					
Comment Code					
Inspector Comment					
FS_ID:10085					
DS_ID:20356					
EP_NO: N/A					
Repair Type: Non-Urgent					
Crossing Status: Found					
UCIP Comments: Headwall undermined 3-4-feet on WS toe.					
FIELD_STRUCT_DESC: 2 of 3: 36-inch steel drainage pipe through levee 30.0 feet below crown. Flap gate on the waterward end. 24-inch pipe sleeved through the 36-inch pipe. Annular space between pipes grouted. Pumps in pumphouse with walkway on LS toe. Originally included in the 1960 O&M manual.					
FS Date: 3/12/2013

Pump house on LS toe.

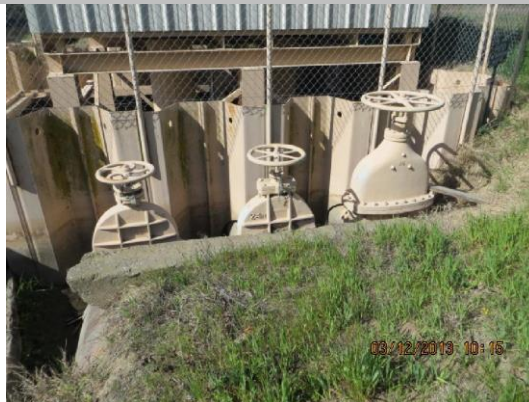
Photo 3 of 3 : UCIP_SP_2017_10085_17225.jpg

LM Start	0.14	Rating **	M	Issue No.	1552 (cont)
LM End	0.14	Issue Type +	Ma	Location *	WS
Category	Supplemental			GPS Latitude/Longitude	
				Start	End
Item	DWR UCIP LMA Responsibility			38.801479 °	38.801479 °
				-121.725176 °	-121.725176 °
DWR ID					
Comment Code					
Inspector Comment					
FS_ID:10085					
DS_ID:20356					
EP_NO: N/A					
Repair Type: Non-Urgent					
Crossing Status: Found					
UCIP Comments: Headwall undermined 3-4-feet on WS toe.					
FIELD_STRUCT_DESC: 2 of 3: 36-inch steel drainage pipe through					
levee 30.0 feet below crown. Flap gate on the waterward end. 24-inch					
pipe sleeved through the 36-inch pipe. Annular space between pipes					
grouted. Pumps in pumphouse with walkway on LS toe. Originally					
included in the 1960 O&M manual.					
FS Date: 3/12/2013

Slide gates at pumphouse on LS toe.

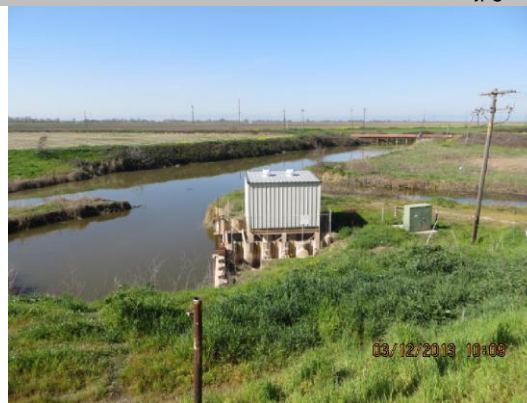
Photo 1 of 3 : UCIP_SP_2017_10910_18185.jpg

LM Start	0.14	Rating **	M	Issue No.	1553
LM End	0.14	Issue Type +	Ma	Location *	WS
Category	Supplemental			GPS Latitude/Longitude	
				Start	End
Item	DWR UCIP LMA Responsibility			38.801491 °	38.801491 °
				-121.725184 °	-121.725184 °
DWR ID					
Comment Code					
Inspector Comment					
FS_ID:10910					
DS_ID:20357					
EP_NO: N/A					
Repair Type: Non-Urgent					
Crossing Status: Found					
UCIP Comments: Headwall undermined 3-4-feet on WS toe.					
FIELD_STRUCT_DESC: 3 of 3: 36-inch steel drainage pipe through					
levee 30.0 feet below crown. Flap gate on the waterward end. 24-inch					
pipe sleeved through the 36-inch pipe. Annular space between pipes					
grouted. Pumps in pumphouse with walkway on LS toe. Originally					
included in the 1960 O&M manual.					
FS Date: 3/12/2013

Pumphouse on LS toe.

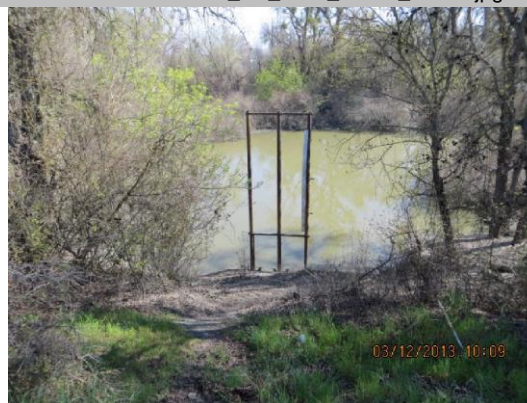
Photo 2 of 3 : UCIP_SP_2017_10910_18184.jpg

Air vents on pipes at WS toe.

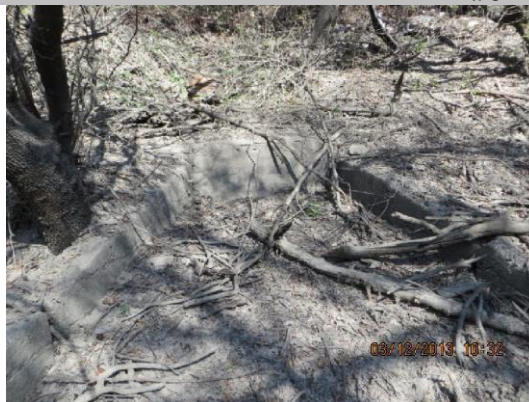
Photo 1 of 1 : UCIP_SP_2017_10088_17237.jpg

LM Start	0.22	Rating **	A/W	Issue No.	1554
LM End	0.22	Issue Type +	Ma	Location *	WS
Category	Supplemental			GPS Latitude/Longitude	
				Start	End
Item	DWR UCIP LMA Responsibility			38.802293 °	38.802293 °
				-121.724847 °	-121.724847 °
DWR ID					
Comment Code					
Inspector Comment					
FS_ID:10088 DS_ID:20327 EP_NO: N/A Repair Type: No Action Needed Crossing Status: Found UCIP Comments: FIELD_STRUCT_DESC: *ABANDONED* 42-inch pipe through levee 28.5 feet below crown. Abandoned in place by plugging with concrete. Headwall on WS toe.Originally included in the 1960 O&M manual. FS Date: 3/12/2013

Concrete headwall visible on WS toe.

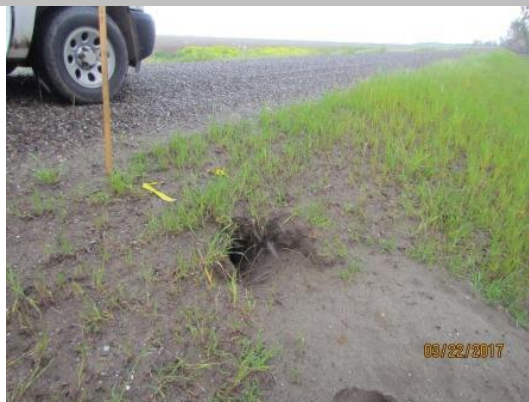
Photo 1 of 1 : SP_2017_NA0016_435_206_20170417_00332.jpg

Burrow on waterside levee shoulder. Spring 2017.

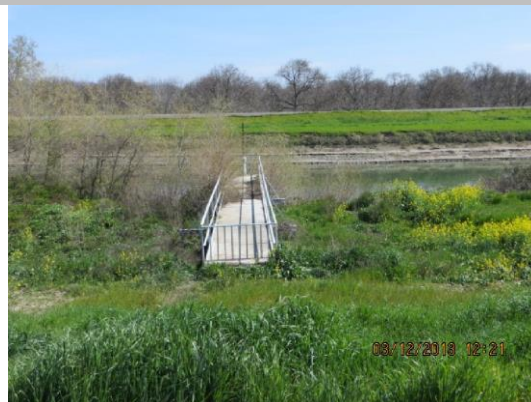
Photo 1 of 3 : UCIP_SP_2017_10125_17283.jpg

LM Start	3.54	Rating **	A/W	Issue No.	1556
LM End	3.54	Issue Type +	Ma	Location *	LS
Category	Supplemental			GPS Latitude/Longitude	
				Start	End
Item	DWR UCIP LMA Responsibility			38.846492 °	38.846492 °
				-121.730066 °	-121.730066 °
DWR ID					
Comment Code					
Inspector Comment					
FS_ID:10125					
DS_ID:20331					
EP_NO: N/A					
Repair Type: No Action Needed					
Crossing Status: Found					
UCIP Comments:					
FIELD_STRUCT_DESC: 5'x 5' concrete tunnel through levee 33.0 feet below crown. Slide gate at outlet on WS toe. Tunnel runs from Concrete V-shaped riser on LS shoulder to WS toe. Steel walkway to slide gate acuator on WS berm. Originally included in the 1960 O&M manual.					
FS Date: 3/12/2013

Steel walkway on WS berm with Slide gate actuator.

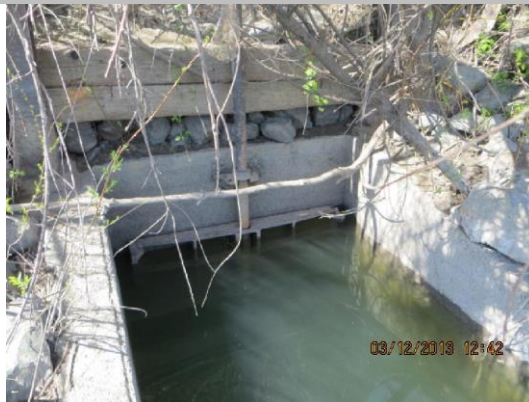
Photo 3 of 3 : UCIP_SP_2017_10125_17281.jpg

LM Start	3.54	Rating **	A/W	Issue No.	1556 (cont)	
LM End	3.54	Issue Type +	Ma	Location *	LS	
Category	Supplemental			GPS Latitude/Longitude		
				Start	End	
Item	DWR UCIP LMA Responsibility			38.846492 °	38.846492 °	
				-121.730066 °	-121.730066 °	
DWR ID						
Comment Code						
Inspector Comment						
FS_ID:10125						
DS_ID:20331						
EP_NO: N/A						
Repair Type: No Action Needed						
Crossing Status: Found						
UCIP Comments:						
FIELD_STRUCT_DESC: 5'x 5' concrete tunnel through levee 33.0 feet below crown. Slide gate at outlet on WS toe. Tunnel runs from Concrete V-shaped riser on LS shoulder to WS toe. Steel walkway to slide gate acuator on WS berm. Originally included in the 1960 O&M manual.						
FS Date: 3/12/2013

Slide gate at outlet at river side.

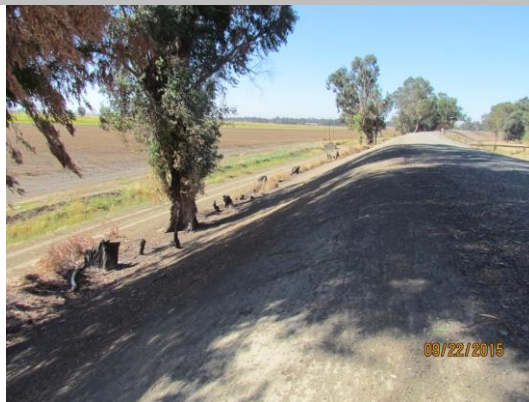
Photo 1 of 1 : SP_2017_NA0016_435_116_20170320_00065.jpg

View of the tree stumps along the landward levee toe looking upstream.
Fall 2015.

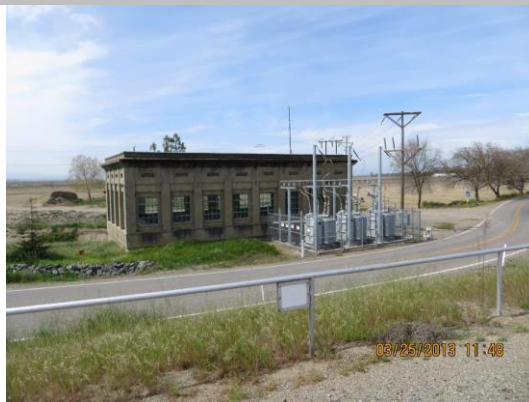
Photo 1 of 3 : UCIP_SP_2017_10147_17316.jpg

LM Start	8.90	Rating **	A/W	Issue No.	1563
LM End	8.90	Issue Type +	Ma	Location *	WS
Category	Supplemental			GPS Latitude/Longitude	
				Start	End
Item	DWR UCIP LMA Responsibility			38.856554 °	38.856554 °
				-121.785613 °	-121.785613 °
DWR ID					
Comment Code					
Inspector Comment					
FS_ID:10147					
DS_ID:20361					
EP_NO: 9376					
Repair Type: No Action Needed					
Crossing Status: Found					
UCIP Comments:					
FIELD_STRUCT_DESC: 2 of 4: 54-inch steel discharge pipe encased in concrete through levee 26.5 feet below crown. (Permit No. 9376, 1960) Gate valves on both ends of the pipes. Walkway provided to the gate valves on WS shoulder. Originally included in the 1960 O&M manual. Pipe not visible on LS toe.					
FS Date: 3/13/2013

Pumphouse on LS toe.

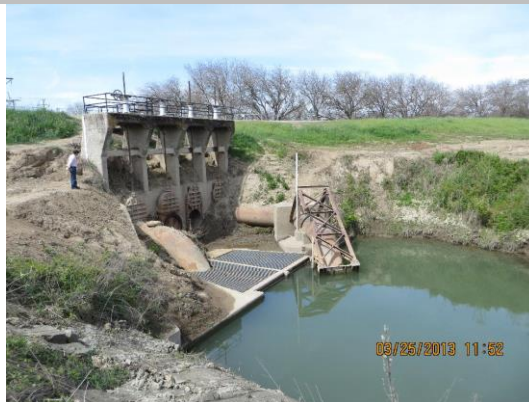
Photo 3 of 3 : UCIP_SP_2017_10147_17314.jpg

LM Start	8.90	Rating **	A/W	Issue No.	1563 (cont)	
LM End	8.90	Issue Type +	Ma	Location *	WS	
Category	Supplemental			GPS Latitude/Longitude		
				Start	End	
Item	DWR UCIP LMA Responsibility			38.856554 °	38.856554 °	
				-121.785613 °	-121.785613 °	
DWR ID						
Comment Code						
Inspector Comment						
FS_ID:10147						
DS_ID:20361						
EP_NO: 9376						
Repair Type: No Action Needed						
Crossing Status: Found						
UCIP Comments:						
FIELD_STRUCT_DESC: 2 of 4: 54-inch steel discharge pipe encased in concrete through levee 26.5 feet below crown. (Permit No. 9376, 1960) Gate valves on both ends of the pipes. Walkway provided to the gate valves on WS shoulder. Originally included in the 1960 O&M manual. Pipe not visible on LS toe.						
FS Date: 3/13/2013

Slide gates and pipes at outlet structure on WS toe.

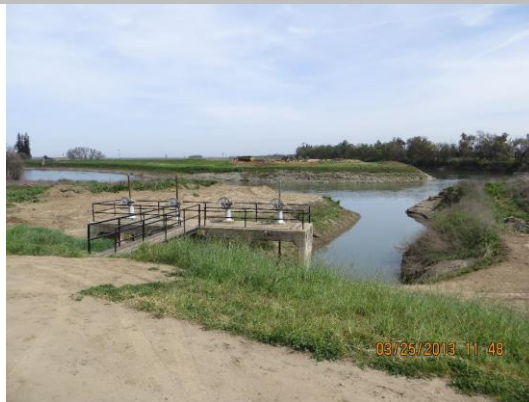
Photo 2 of 3 : UCIP_SP_2017_10148_17319.jpg

Slide gate actuators on platform at WS shoulder.

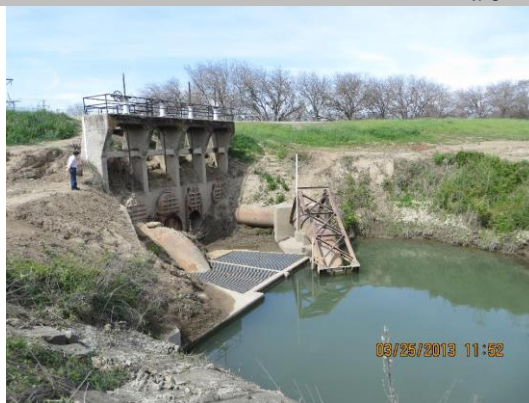
Photo 3 of 3 : UCIP_SP_2017_10149_17322.jpg

LM Start	8.90	Rating **	A/W	Issue No.	1565 (cont)	
LM End	8.90	Issue Type +	Ma	Location *	WS	
Category	Supplemental			GPS Latitude/Longitude		
				Start	End	
Item	DWR UCIP LMA Responsibility			38.856608 °	38.856608 °	
				-121.785622 °	-121.785622 °	
DWR ID						
Comment Code						
Inspector Comment						
FS_ID:10149						
DS_ID:20363						
EP_NO: 9376						
Repair Type: No Action Needed						
Crossing Status: Found						
UCIP Comments:						
FIELD_STRUCT_DESC: 4 of 4: 54-inch steel discharge pipe encased						
in concrete through levee 26.5 feet below crown. (Permit No. 9376,						
1960) Gate valves on both ends of the pipes. Walkway provided to the						
control valves. Originally included in the 1960 O&M manual.						
FS Date: 3/13/2013

Pipes and slide gates at outlet on WS.

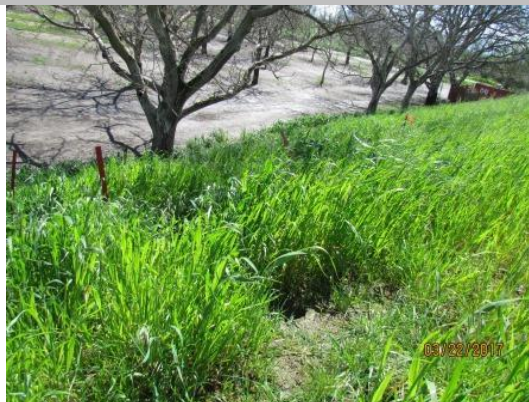
Photo 1 of 1 : SP_2017_NA0016_435_226_20170417_00340.jpg

Rodent burrow on landside levee slope. Spring 2017.

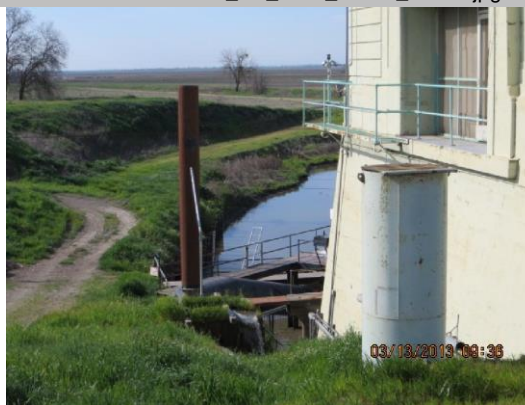
Photo 2 of 3 : UCIP_SP_2017_10163_17341.jpg

LM Start	9.75	Rating **	A/W	Issue No.	1567
LM End	9.75	Issue Type +	Ma	Location *	WS
Category	Supplemental			GPS Latitude/Longitude	
				Start	End
Item	DWR UCIP LMA Responsibility			38.862619 °	38.862619 °
				-121.792510 °	-121.792510 °
DWR ID					
Comment Code					
Inspector Comment					
FS_ID:10163 DS_ID:20415 EP_NO: 680 Repair Type: No Action Needed Crossing Status: Found UCIP Comments: FIELD_STRUCT_DESC: 42-inch steel pipe through levee 17.5 feet below crown. Screw gate on the waterward end. Pump on platform in canal on LS toe. 12-inch standpipe along alignment on LS toe. (Permit No. 680, 1936). Staff gauge to 47.0 feet on structure. Included in the 1960 O&M manual. FS Date: 3/13/2013

12-inch steel standpipe at LS toe with 36-inch steel riser.

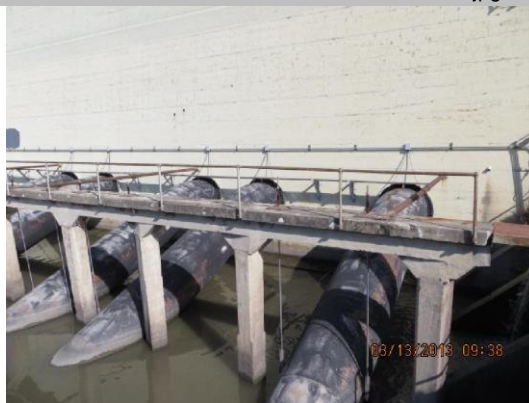
Photo 2 of 3 : UCIP_SP_2017_10164_17344.jpg

LM Start	9.75	Rating **	A/W	Issue No.	1568 (cont)
LM End	9.75	Issue Type +	Ma	Location *	WS
Category	Supplemental			GPS Latitude/Longitude	
				Start	End
Item	DWR UCIP LMA Responsibility			38.862615 °	38.862615 °
				-121.792582 °	-121.792582 °
DWR ID					
Comment Code					
Inspector Comment					
FS_ID:10164					
DS_ID:20232					
EP_NO: N/A					
Repair Type: No Action Needed					
Crossing Status: Found					
UCIP Comments:					
FIELD_STRUCT_DESC: 1 of 5: 60-inch concrete culverts through levee					
35.0 feet below crown. Screw gates on walkway at waterside shoulder.					
(O&M, 1960). Staff gauge to 47.0 feet on structure.					
FS Date: 3/13/2013

Pipes at entrance to pumping plant building on LS toe.

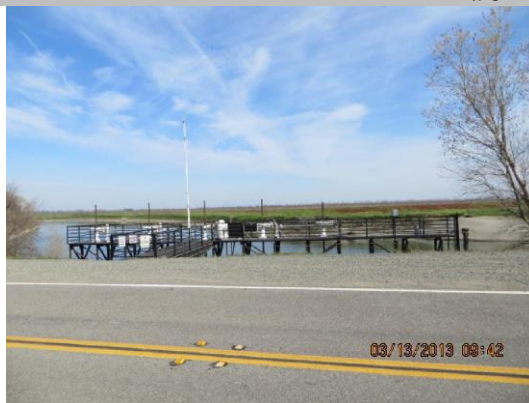
Photo 3 of 3 : UCIP_SP_2017_10164_17343.jpg

Slide gate actuators on WS shoulder.

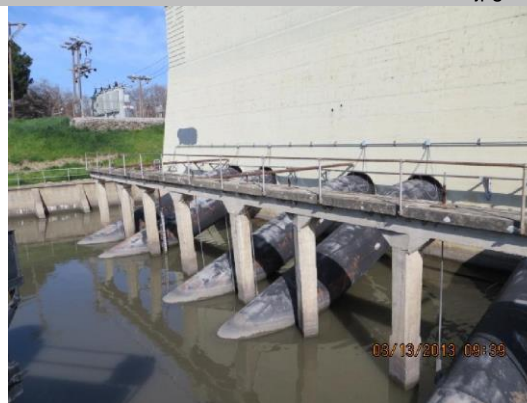
Photo 2 of 3 : UCIP_SP_2017_10168_17359.jpg

Pipe at inlet to pumphouse on LS toe.

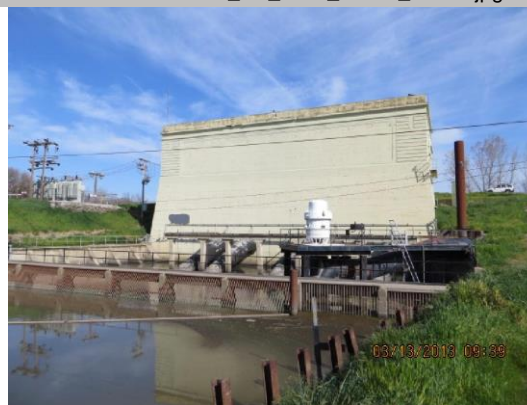
Photo 3 of 3 : UCIP_SP_2017_10168_17358.jpg

Pumphouse on LS.

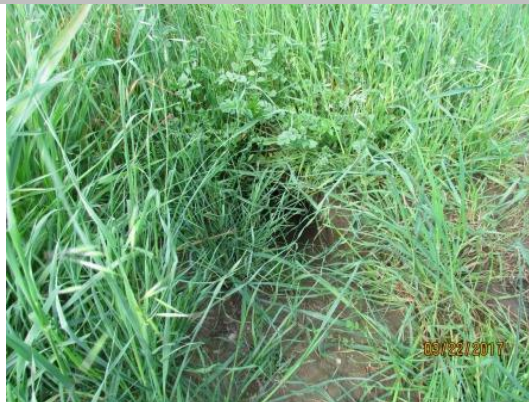
Photo 1 of 1 : SP_2017_NA0016_435_233_20170417_00341.jpg

Rodent burrow on landside levee slope. Spring 2017.

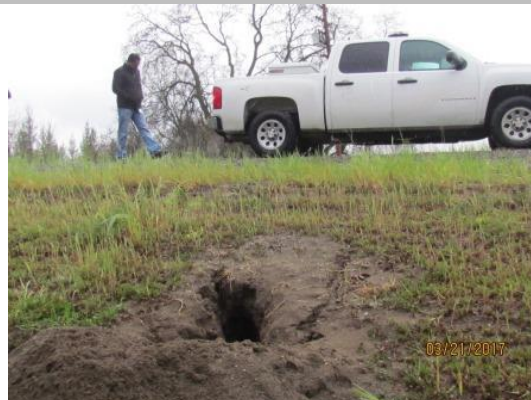
Photo 1 of 1 : SP_2017_NA0016_435_140_20170414_00314.jpg

Large burrow on landside levee slope. Most likely foxes. Spring 2017.

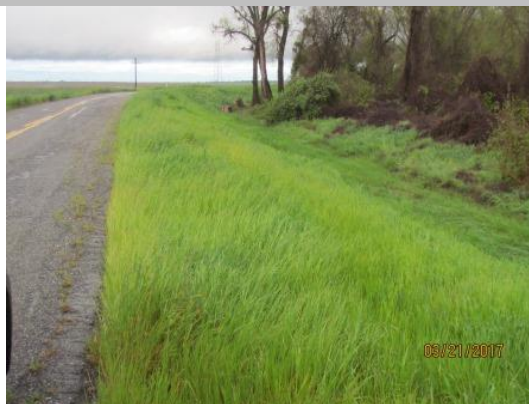
Photo 1 of 1 : SP_2017_NA0016_435_142_20170414_00316.jpg

Tall vegetation on landside slope. Spring 2017.

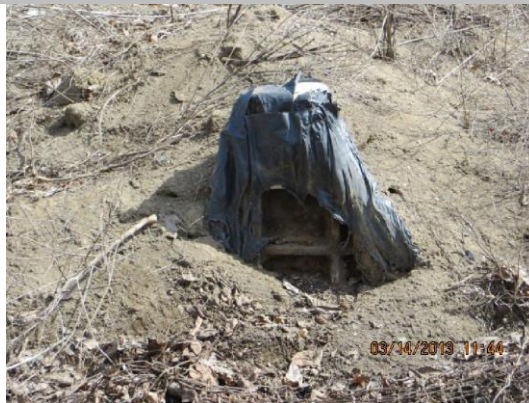
Photo 2 of 3 : UCIP_SP_2017_10291_17547.jpg

Gate valve buried on LS toe.

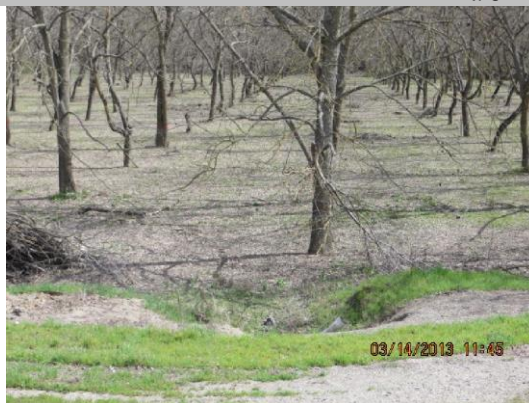
Photo 3 of 3 : UCIP_SP_2017_10291_17546.jpg

Excavation at WS toe where pipe should be.

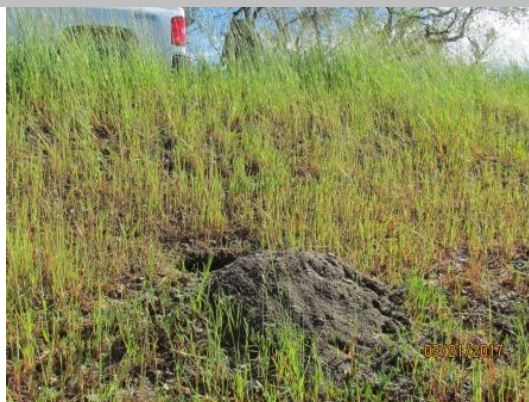
Photo 1 of 2 : SP_2017_NA0016_435_79_20170414_00320.jpg

Large animal burrow on landside slope. Spring 2017.

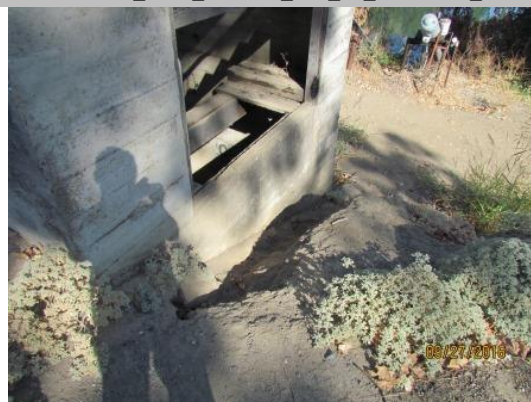
Photo 1 of 1 : SP_2017_NA0016_435_80_20170320_00035.jpg

Slope stability issue at the wall of the building. Waterside slope. Fall 2016 inspection.

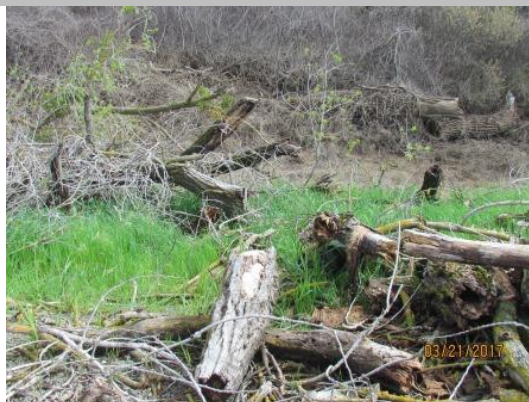
Photo 1 of 1 : SP_2017_NA0016_435_164_20170417_00326.jpg

Fallen tree on landside levee slope. Spring 2017.

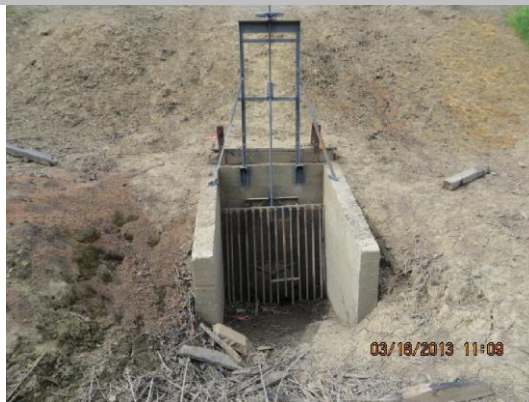
Photo 3 of 3 : UCIP_SP_2017_10426_17703.jpg

Outlet/inlet on WS toe.

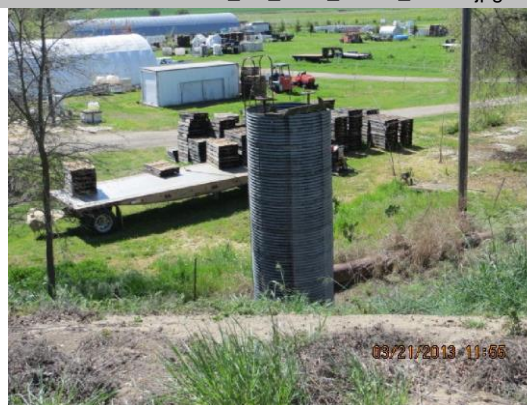
Photo 2 of 3 : UCIP_SP_2017_10535_17876.jpg

6-foot diameter CMP riser with slide gates on LS toe.
